1. Project Name: Agat SBH
2. Date of Inspection: July 20, 2007
3. Inspection Personnel:

4. Discussion:

The overall condition of the project is good, however several unauthorized chains could jeopardize the breakwater's structural integrity during a major storm.

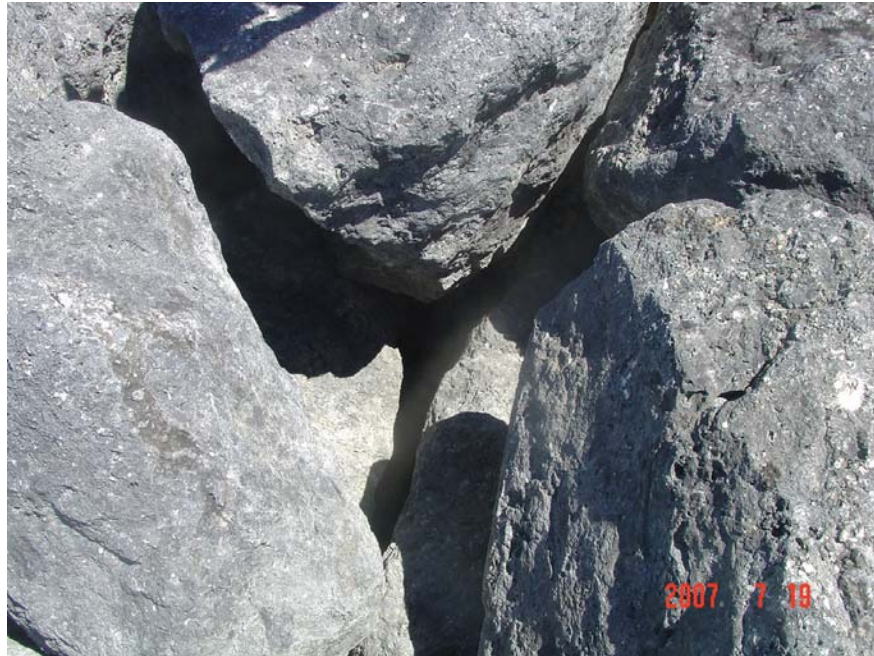
a. Sta. 0-35, Crest/Sideslope, Void, the missing armor stones appear to be resting on the OS @ 15 deg. of the structure. No Change (NC) this year

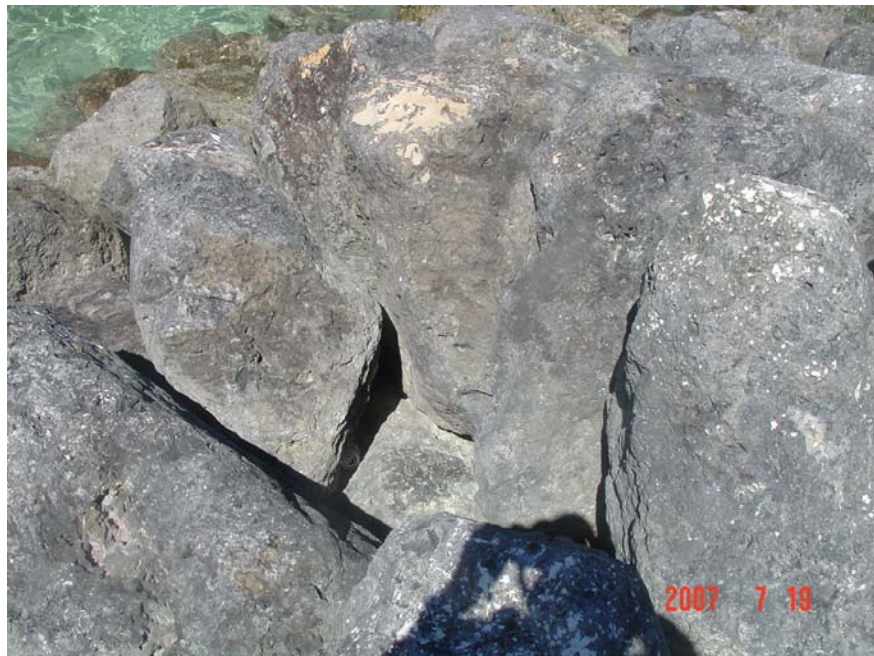
b. Sta. 0-30, Crest/Sideslope, Void, the missing armor stones appear to be resting on the OS of the structure. (FY03 photo, NC)

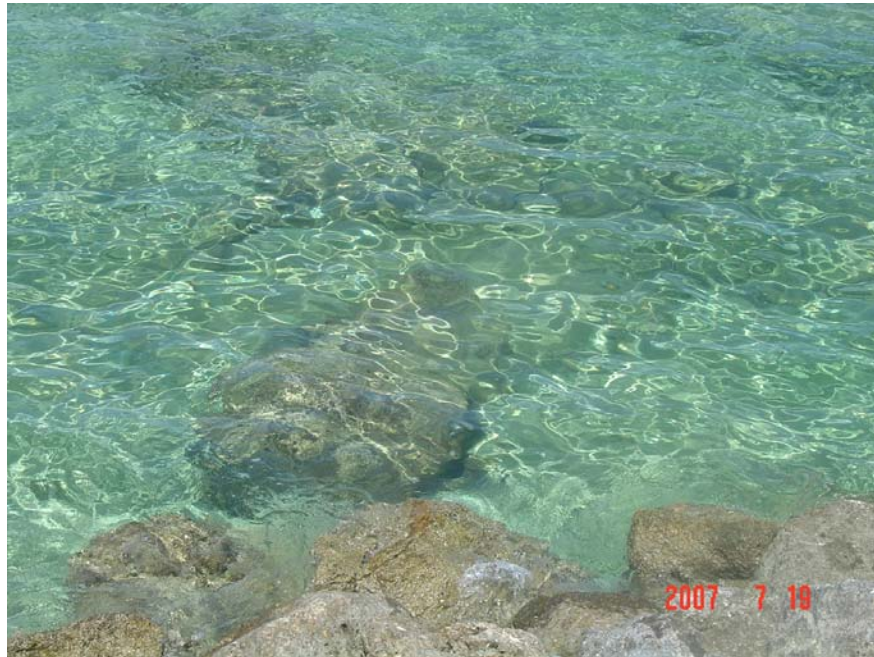
c. Sta. 0-35, 2 ea. armor stones (AS) are resting adjacent the structure. These AS may be from the above identified voids.

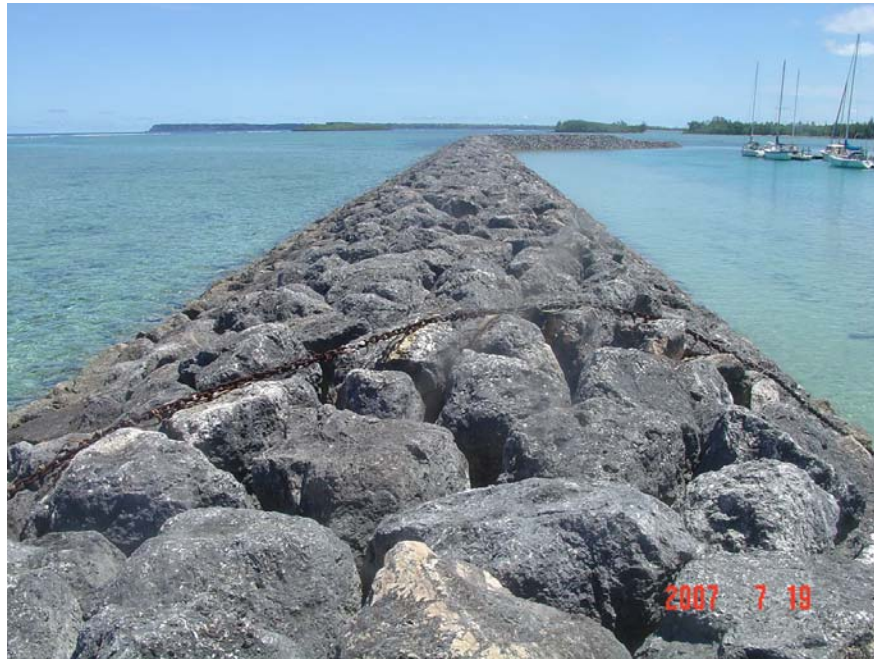
e. Sta. 0+82, OS, Remove chain.

Vegetation removal from the structures should be accomplished before conditions worsen. The chains that are installed by persons unknown, on the main breakwater needs to be removed. These are used for temporary mooring during storms and have not been designed into the project. In FY03 this issue was discussed in a meeting with Mr. Simion DeLosSantos and Deputy Director, Mr. Paul M. Shintaku of Guam Port Authority. The Corps' concerns were re-iterated regarding the encroachment into the access channel and turning basin and its associated potential hazards. Per my discussions with Mr. Simmion DeLosSantos, GPA does not have the funds to remove the chains, however would be willing to issue a notice to boaters informing them the COE will be removing the chains prior to any action.

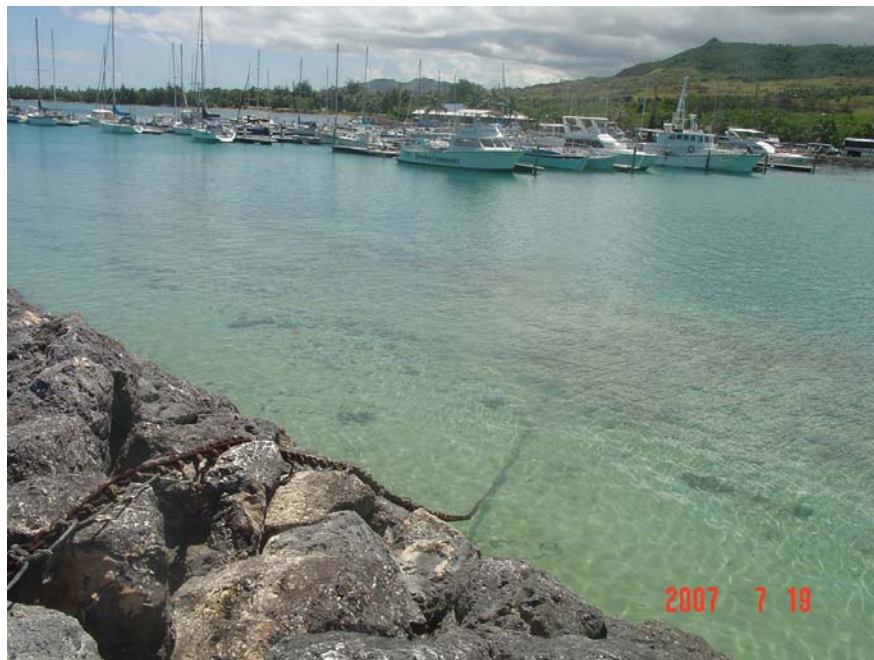
f. Sta. 1+00, HS, Un-authorized Anchor chain crossing channel.

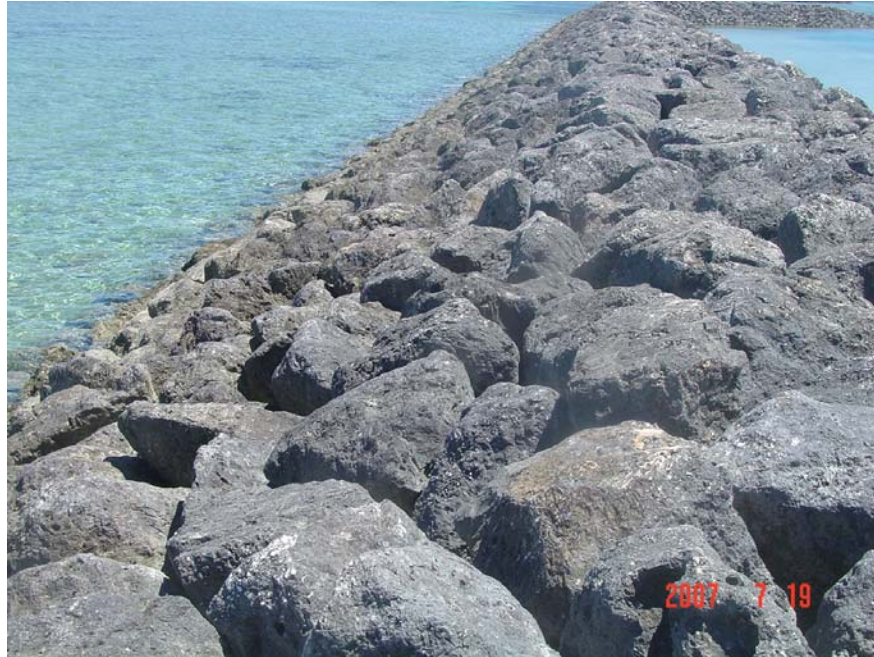
g. Sta. 1+62, OS, Monitor slight settling on the sideslope.

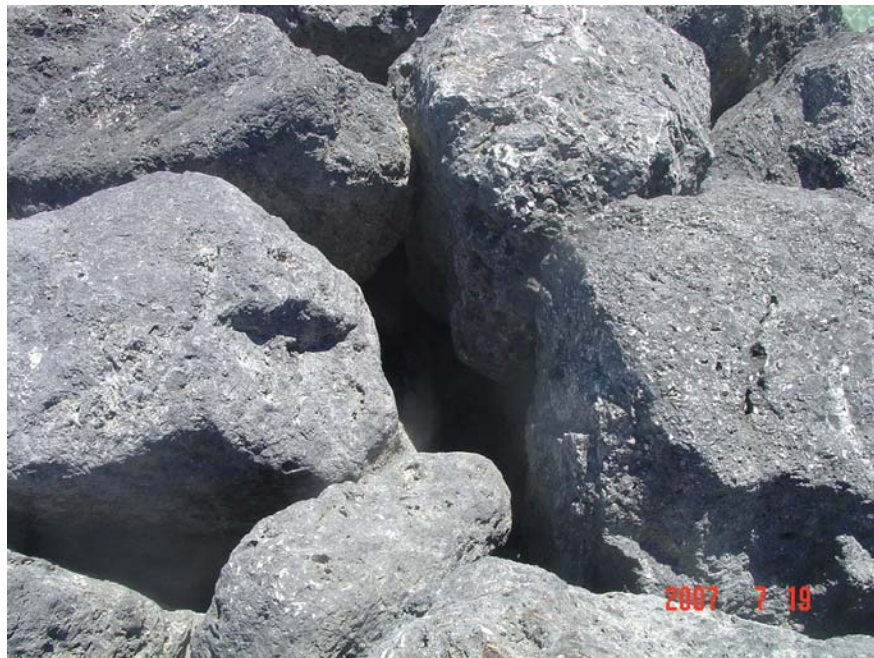
h. Sta. 1+62, CL, 1' x 3' void at crest.

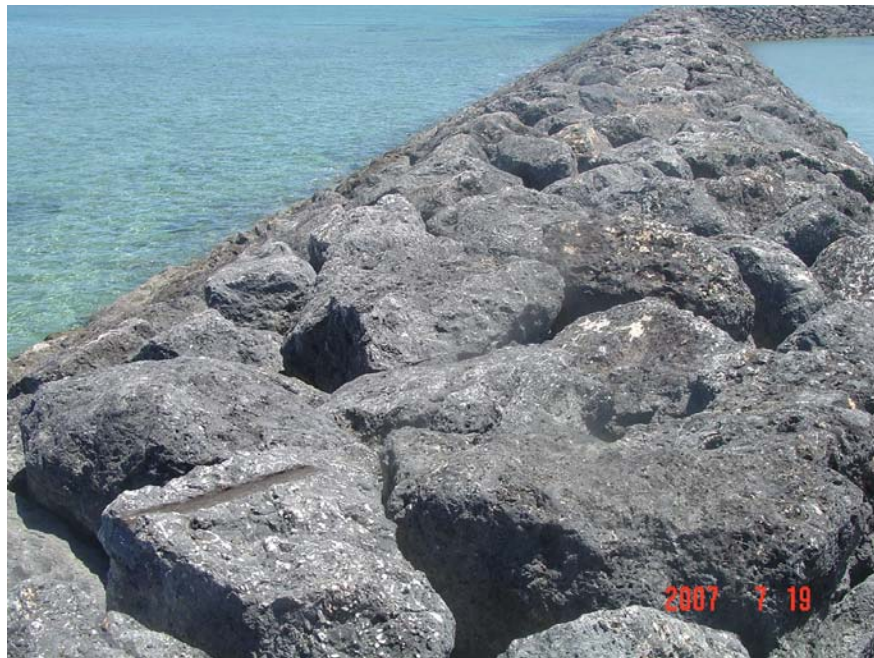
j. Sta. 2+98, Overview w/reference point, slight settling at Sta. 3+00 (no change this year).

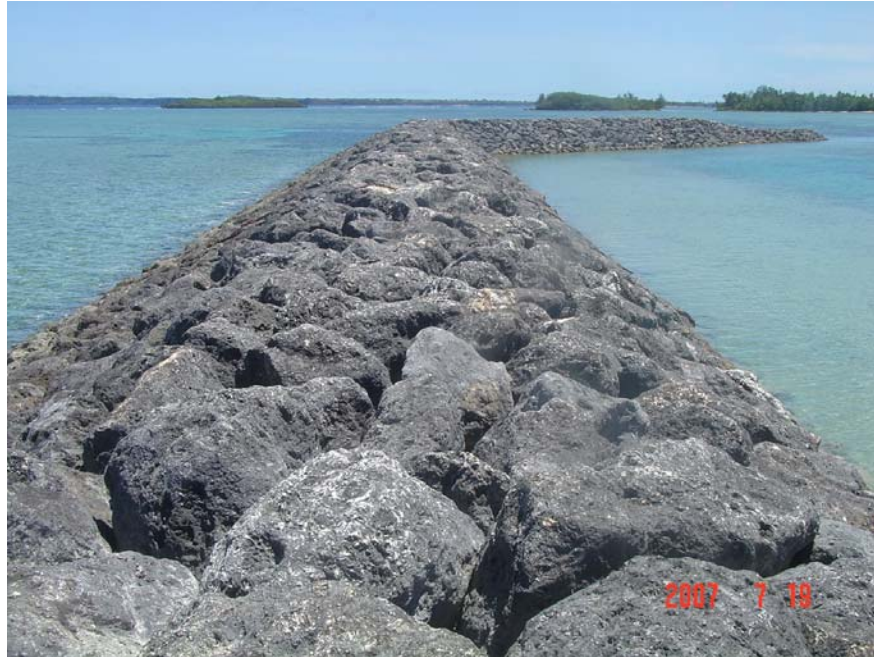
k. Sta. 3+59, CL, Monitor minor settling.

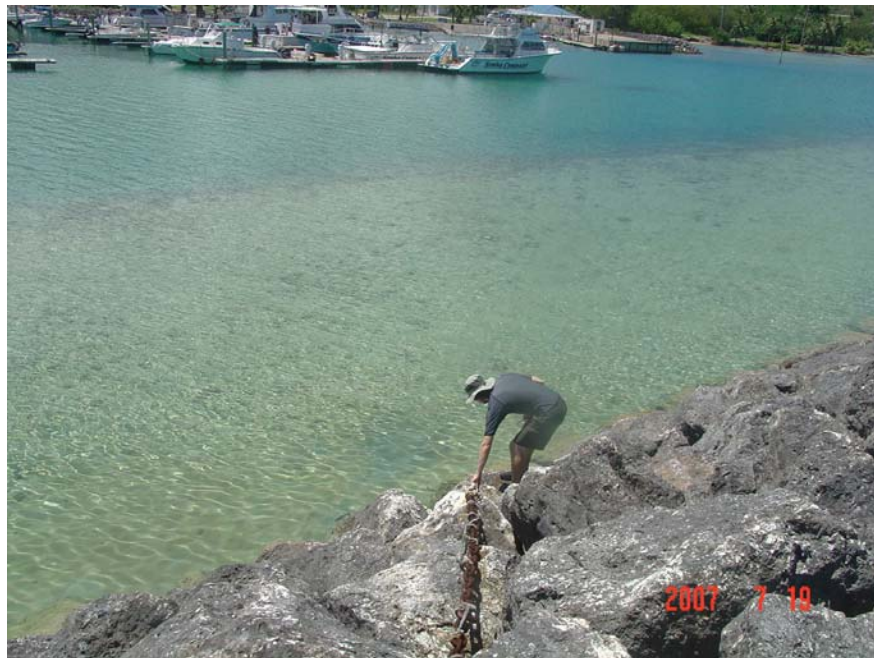
l. Sta. 3+90, HS, Remove chains, no longer crosses chnl
appears to be broken.

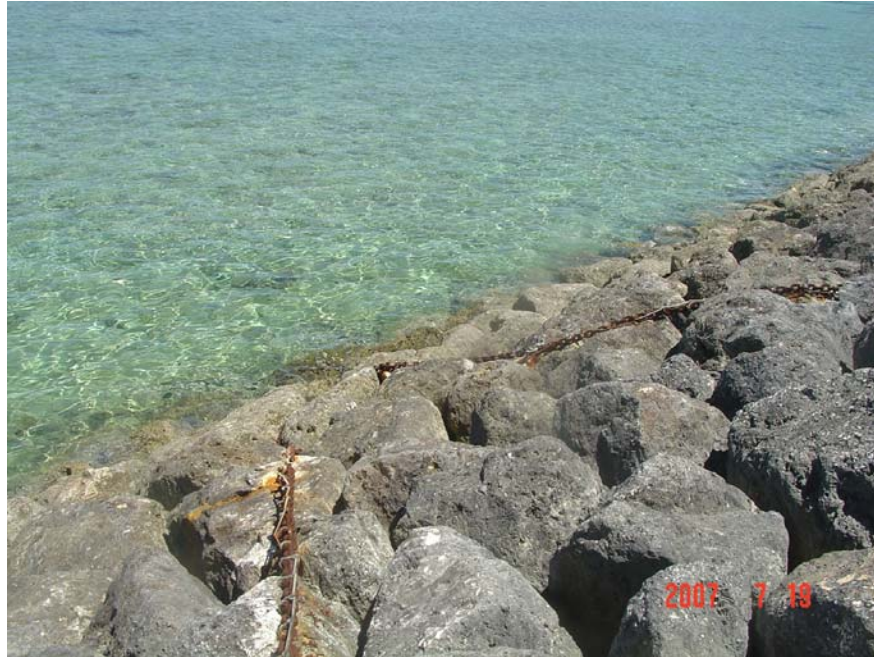
m. Sta. 4+04, OS, Remove chains.

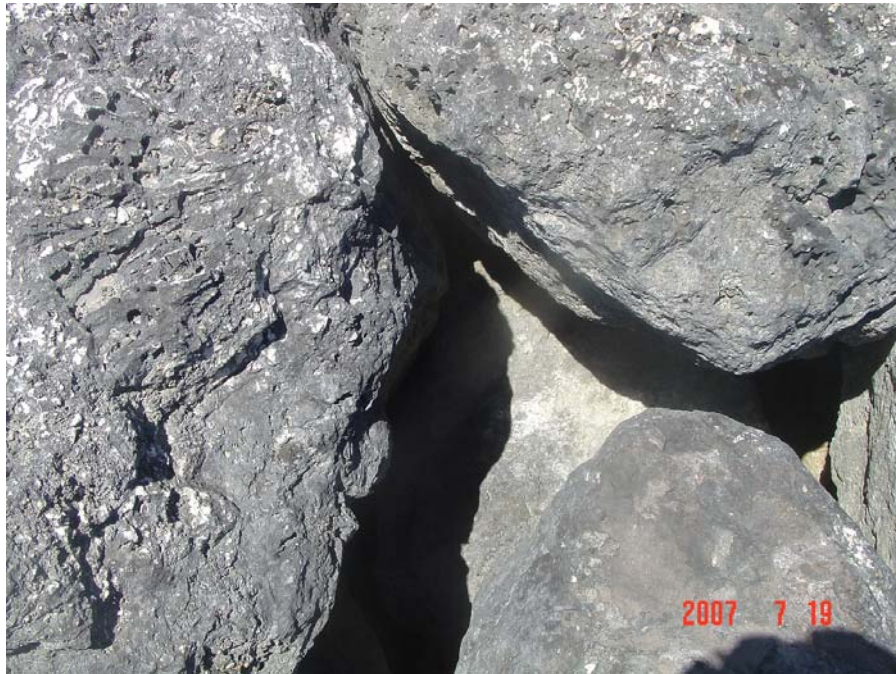
n. Sta. 4+31, Small void.

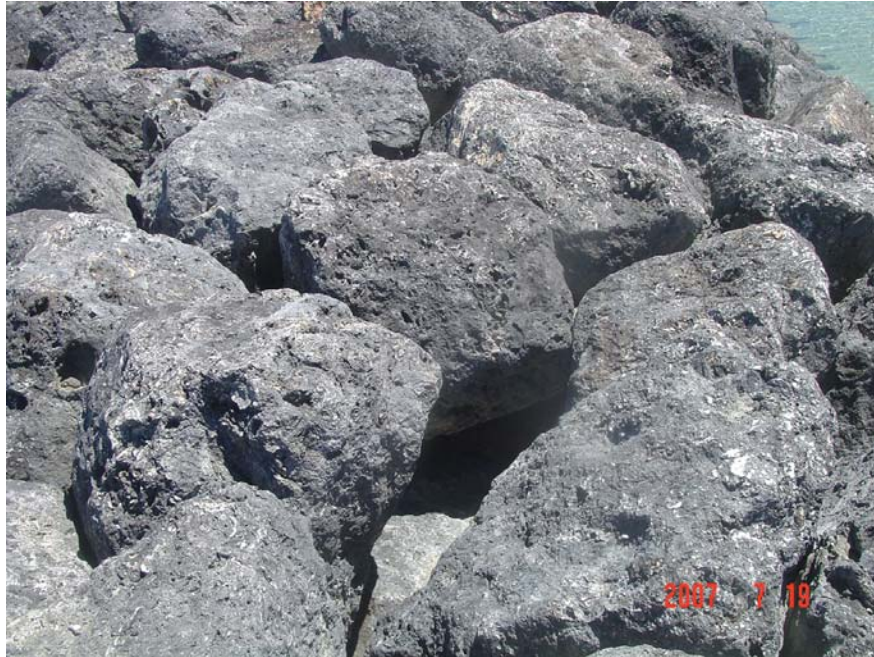
o. Sta. 4+34, CL, Void (no change this year).

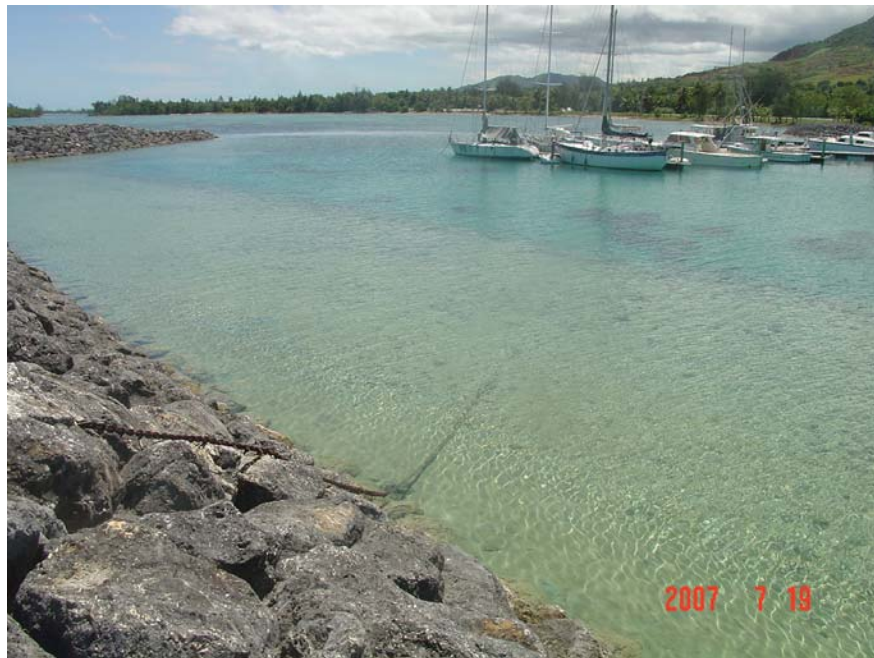
p. Sta. 4+34, HS, Remove chain in access channel (no change this year).

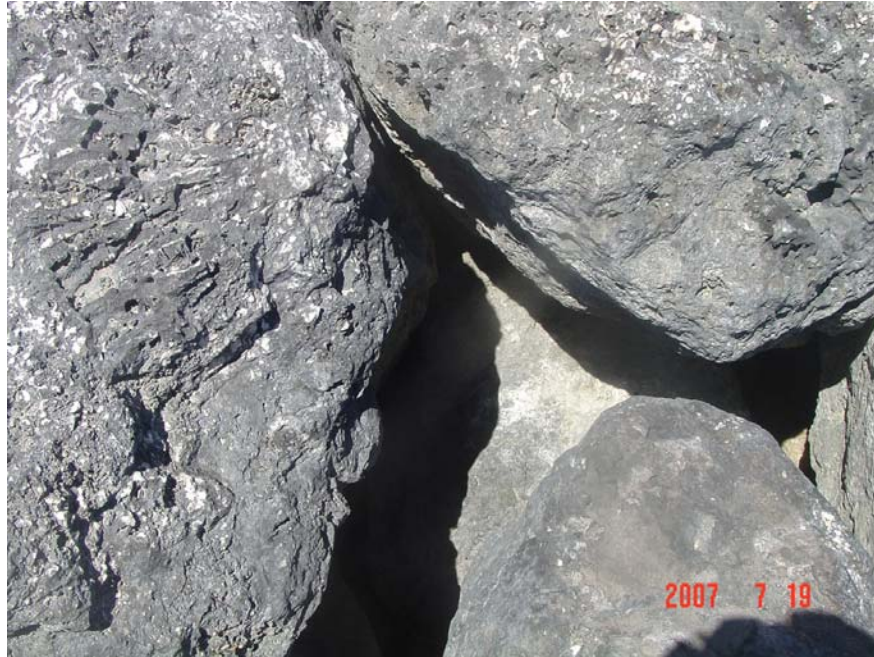
q. Sta. 4+44, CL, Monitor small void, no obvious settling.

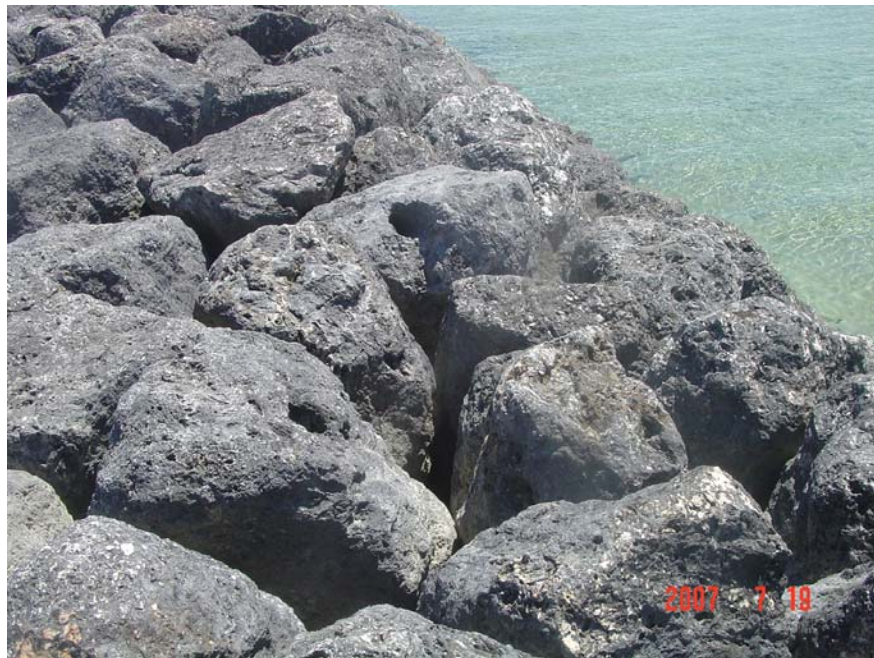
r. Sta. 4+55, CL, 2' x 2' x 10' void (new this year).

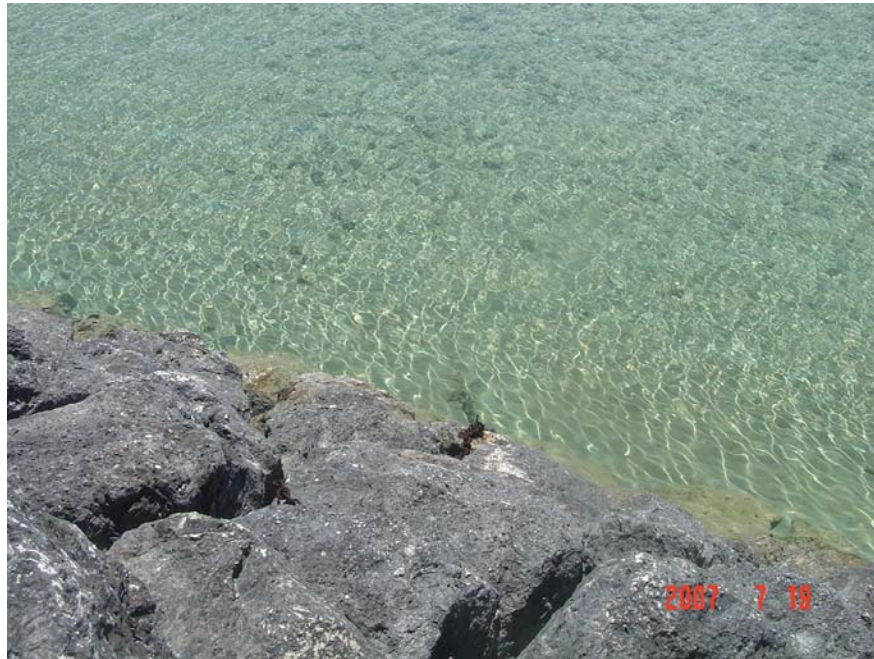
s. Sta. 4+95, HS, Remove chains, hard to see in silt.

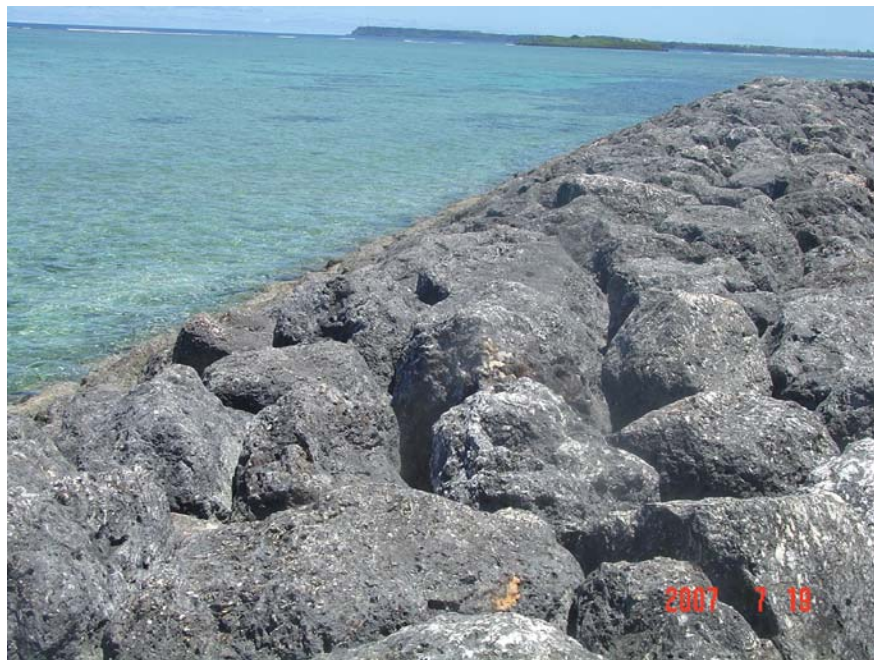
t. Sta. 5+00, OS, slight settling at crest.

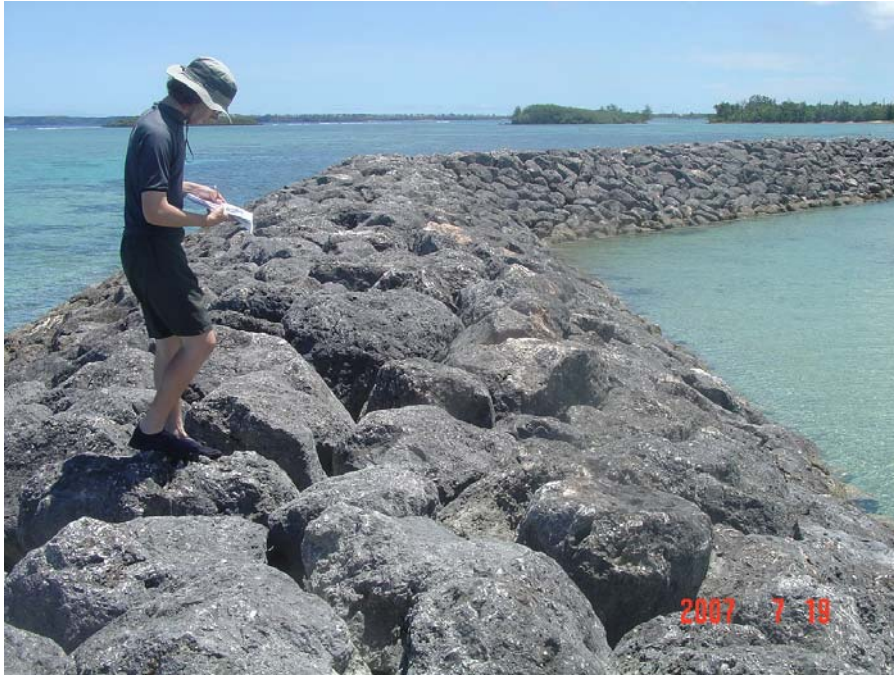
u. Sta. 5+71, HS of CL, Monitor slight settling.

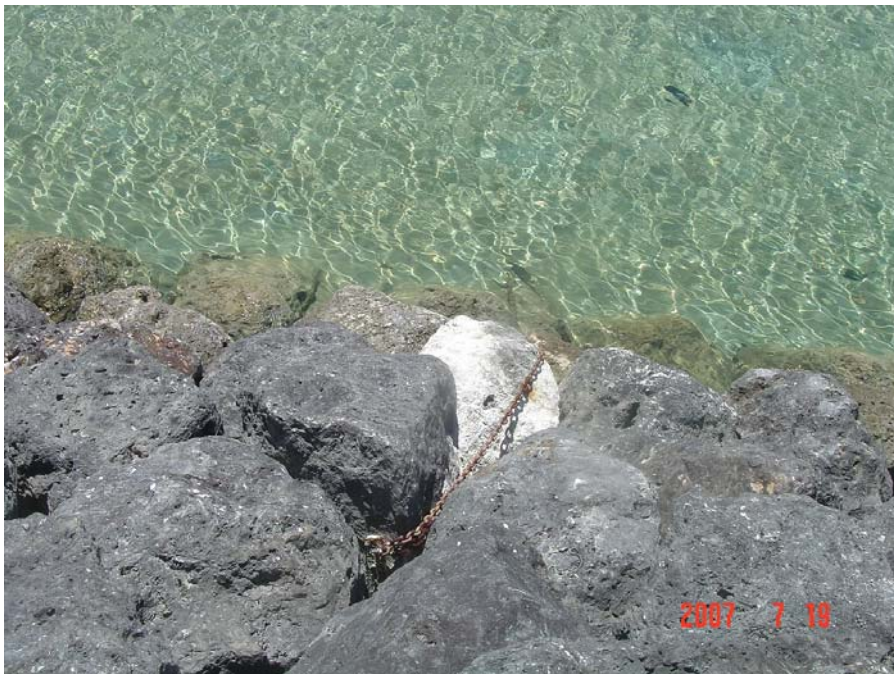
v. Sta. 6+00, HS, Chain w/metal spike.

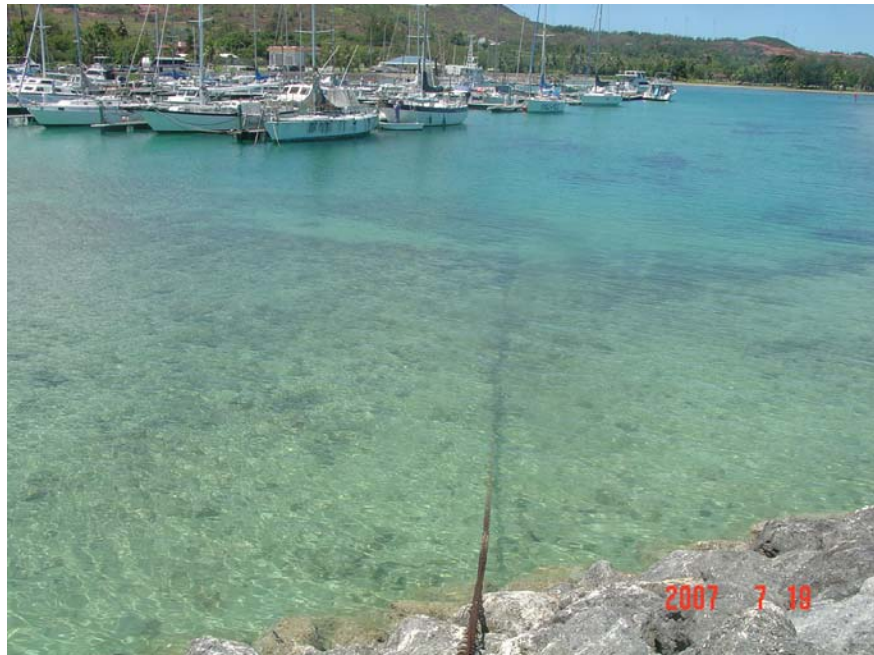
x. Sta. 8+75, HS, Remove chain in access channel.

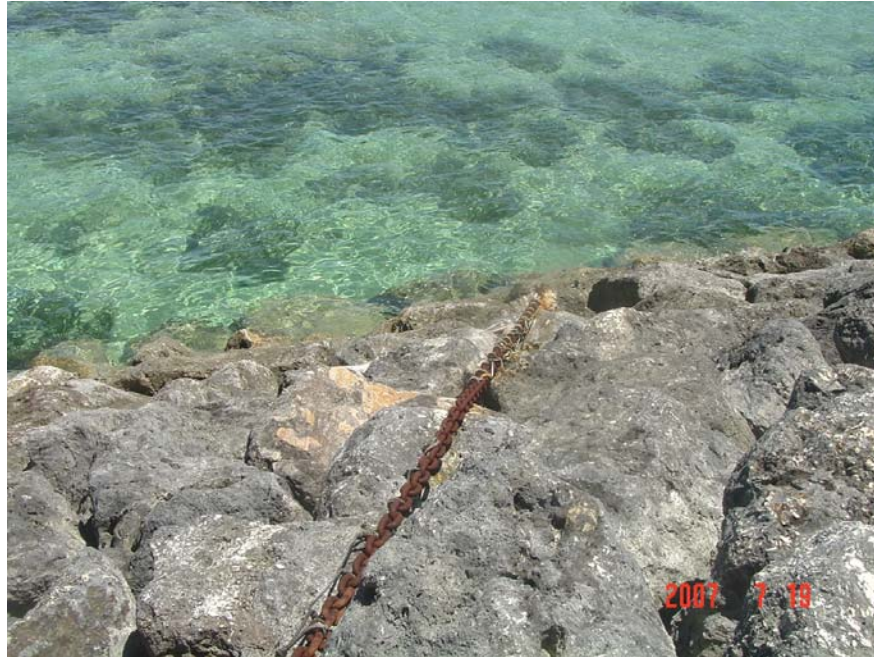
y. Sta. 8+75, OS, Remove chain.

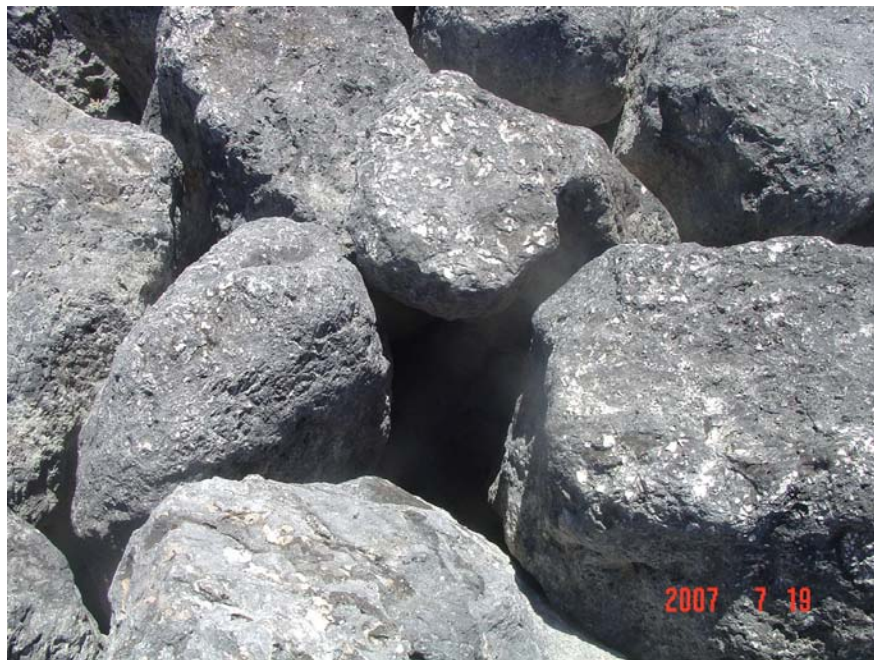
z. Sta. 8+83, small void on centerline of crest.

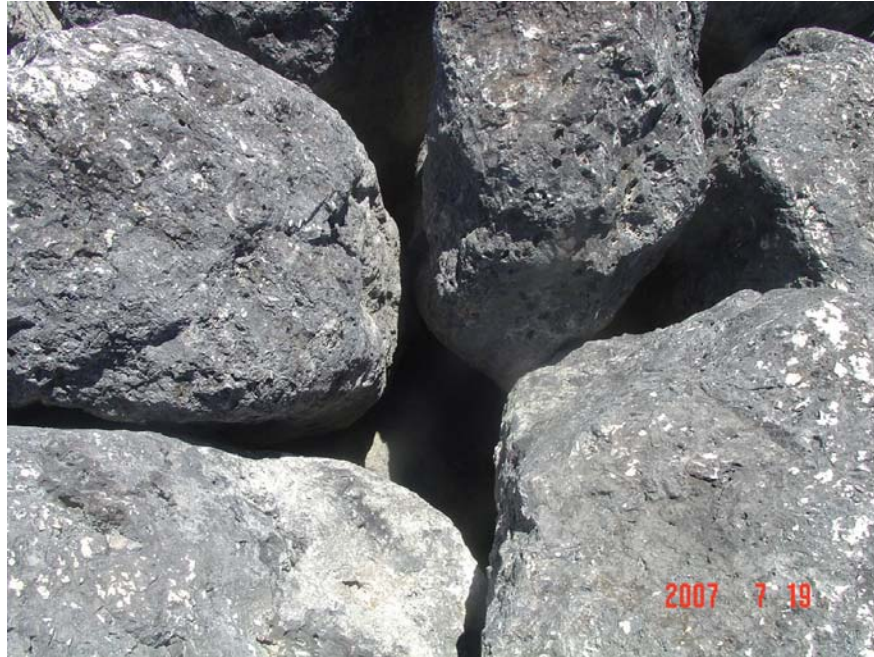
aa. Sta. 8+95, CL, Monitor void area, no change this year.

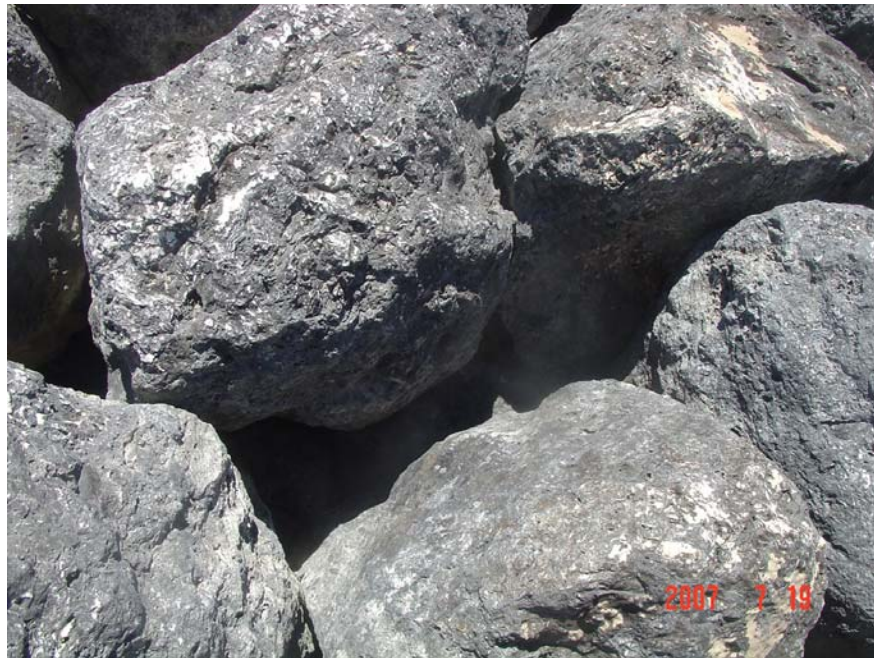
bb. Sta.9+05, CL, Monitor void.

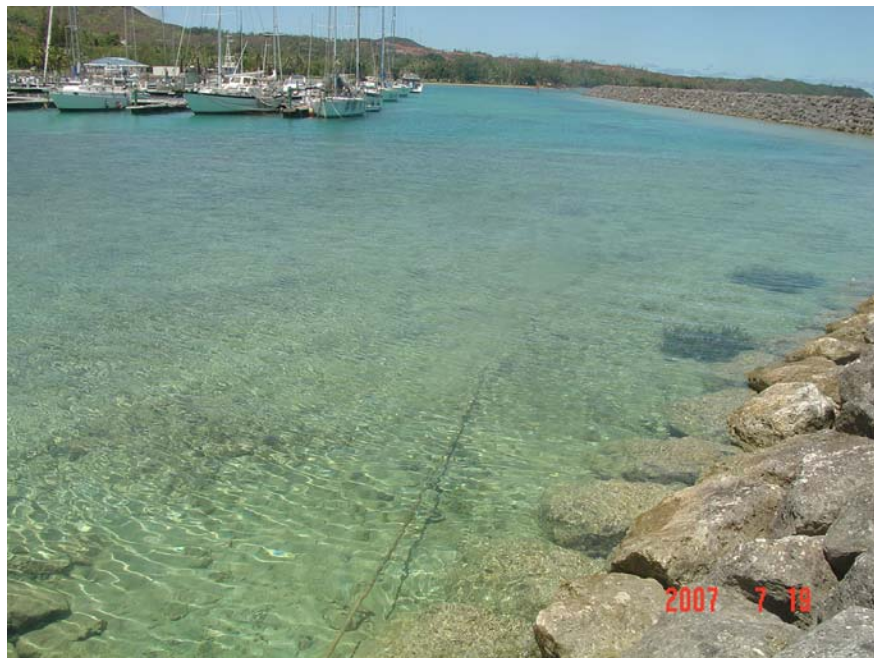
dd. Sta. 9+16, Rope and chain.

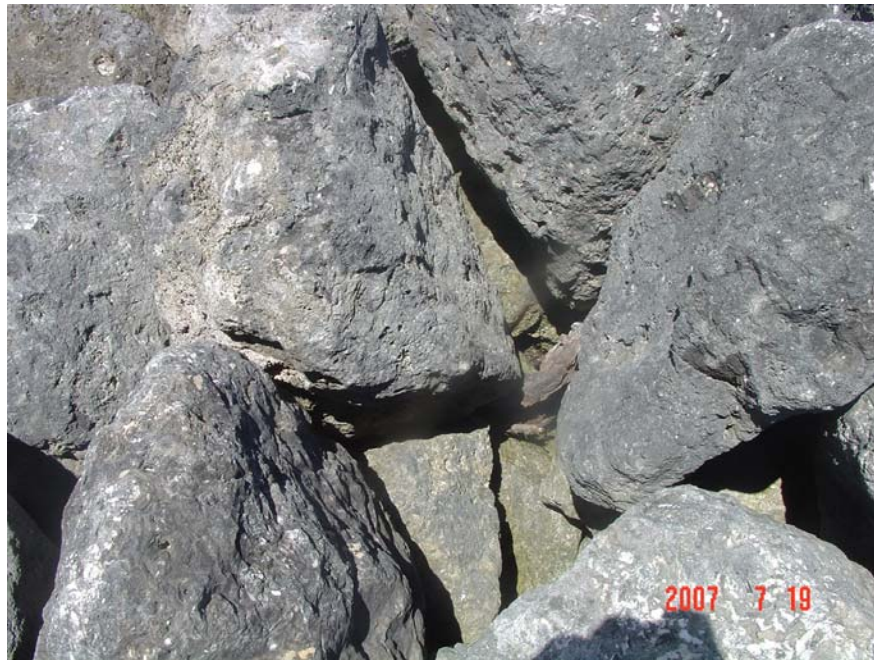
ee. Sta. 8+99, CL, Monitor void area. No Change this year.

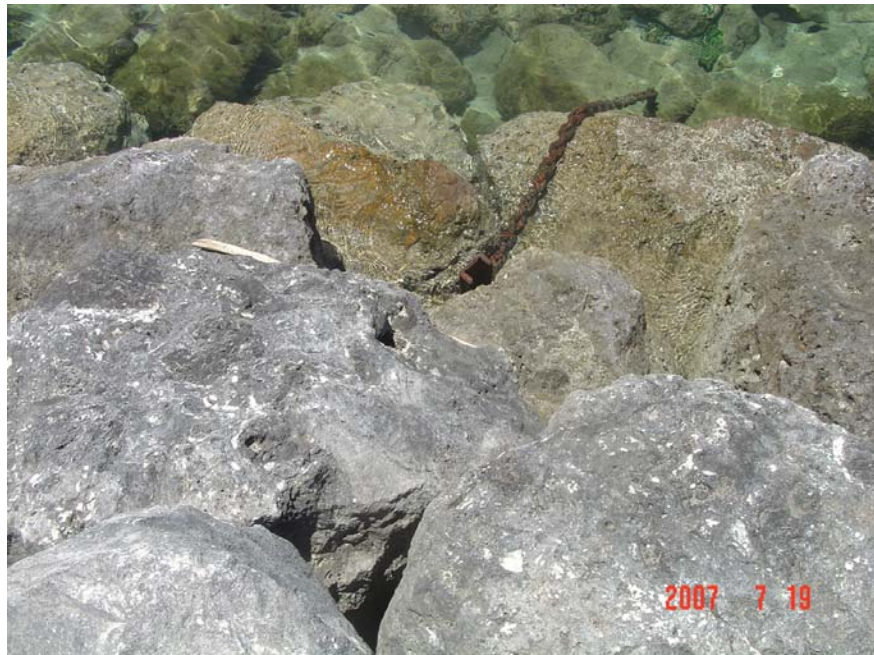
ff. Sta. 9+25, HS, Remove chain and anchor.

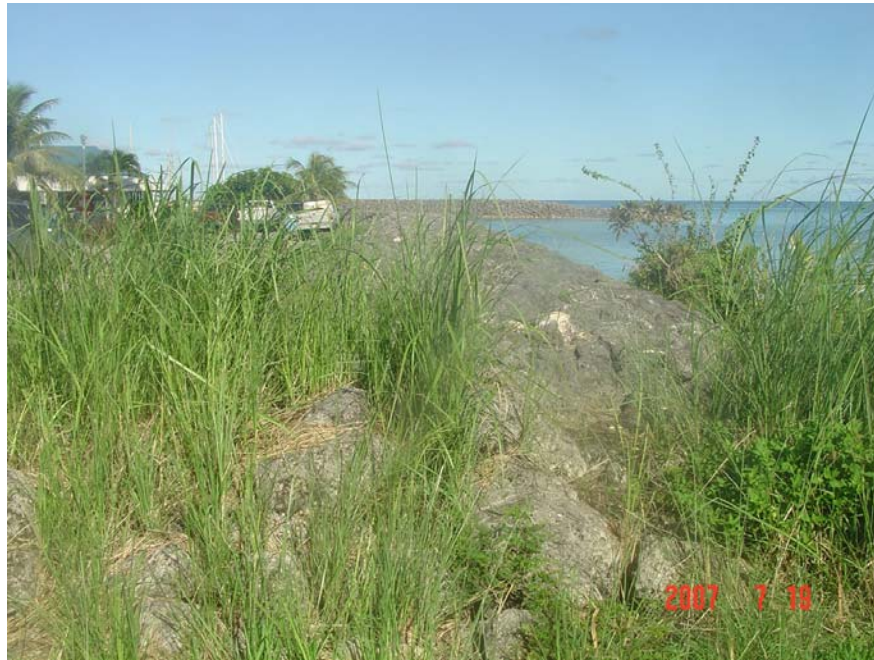
- b. Sta. 0+00, Note: 0+66, OS, Tree has been cut, still existing vegetation on crest.

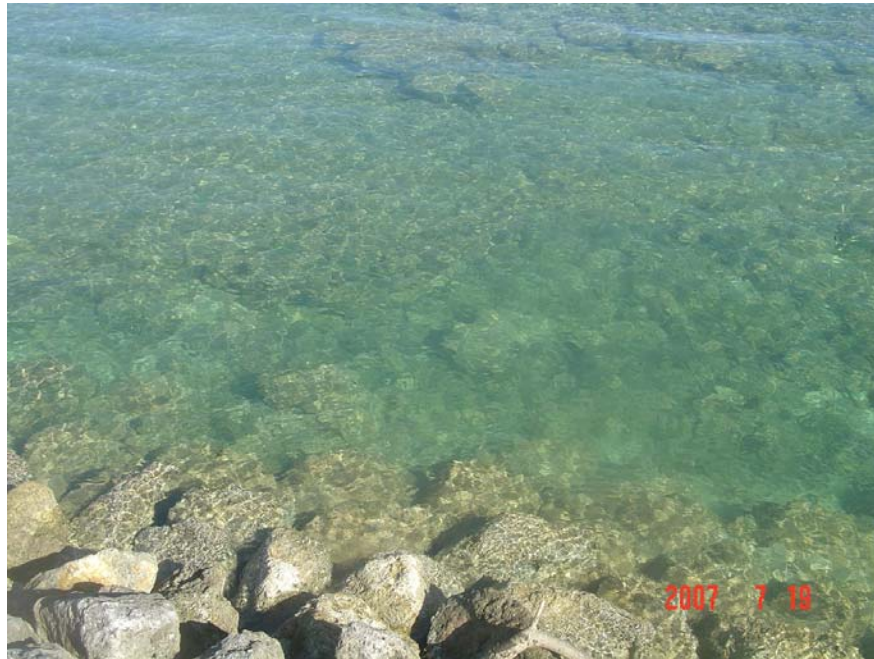
d. Sta. 2+68, OS, Monitor the toe of the structure and dislocated armor stones at this area. This area at the intersection of the berthing area dredge cut and the reef flat has "scoured" a small channel. No Change this year.

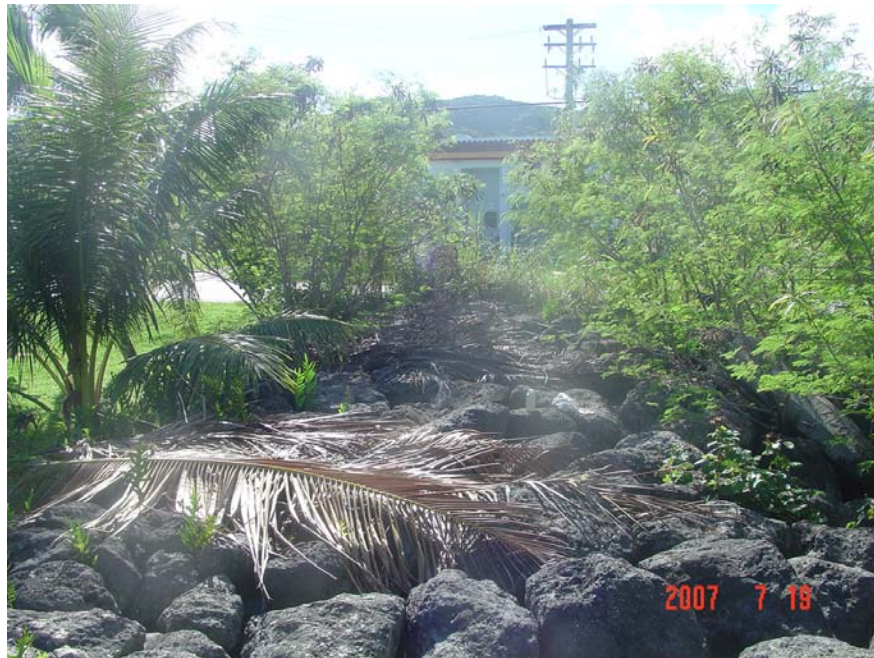
a. Sta. 0+00 to Sta. 0+60, HS, Remove vegetation worse than last year.

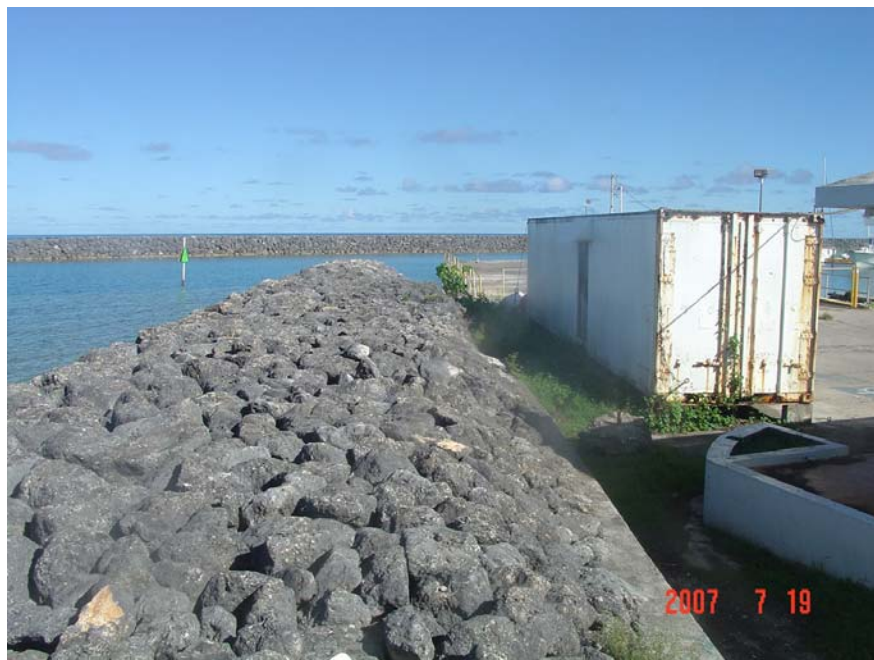
b. Sta. 0+33 to Sta. 1+70, HS, Structure modified.

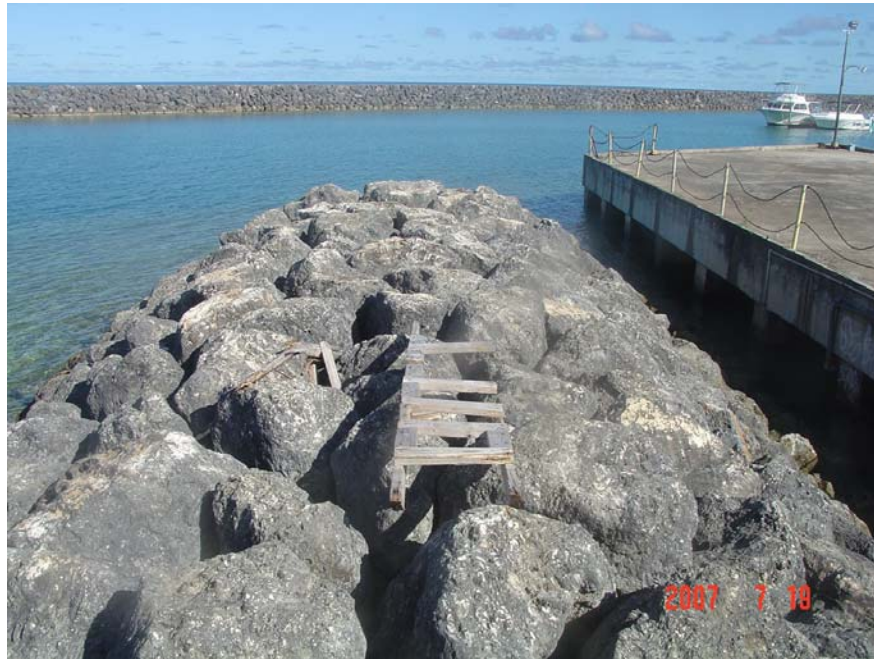
b. Sta. 0+34, CL, Monitor slight settling.

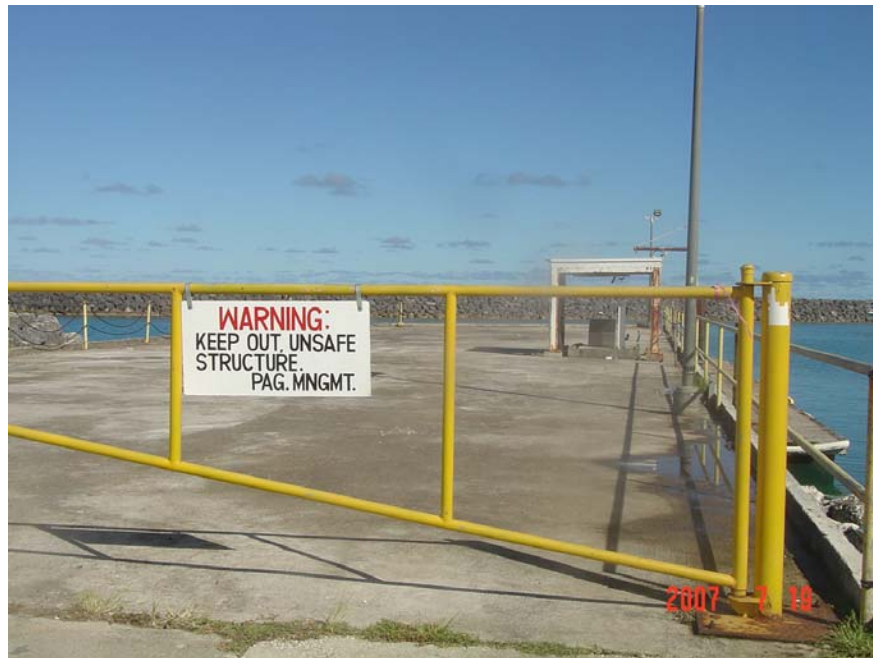
Fuel Dock is settling and can not be used.

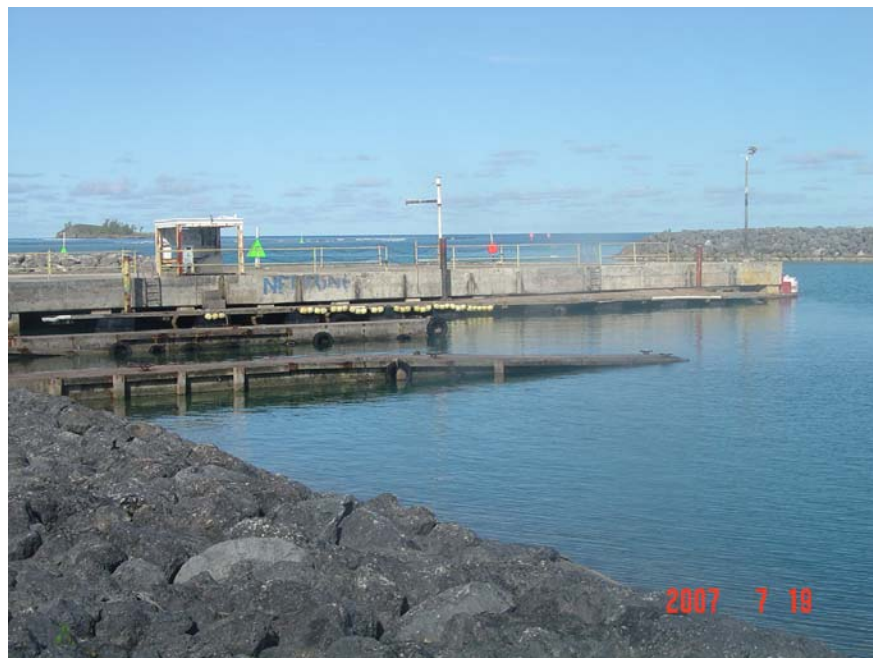
The Federally Constructed-Locally Owned Boat Ramp Dock has major damages as the piles have failed.
